Trinity
Episcopal
Cathedral

FEASIBILITY ASSESSMENT +
MASTER PLAN FALL 2021

| POLK | STANLEY | WILCOX

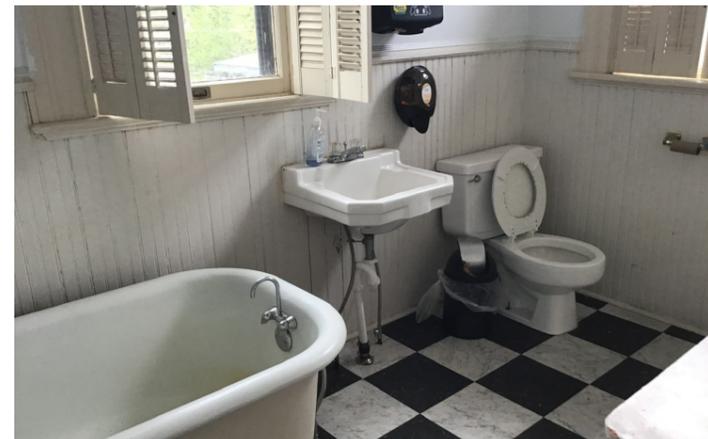
The kitchen and all bathrooms in their current state are unusable and in need of complete renovation. In the kitchen there is one wall cupboard that may be original to the house which could be saved for its historic value. Otherwise all other cabinetry, counter tops and appliances should be replaced. It is the architect’s opinion that only one of the three bathrooms is original to the house due to its period fixtures and wainscoting. The other two restrooms appear to be poorly executed remodels. None of the three bathrooms are ADA compliant.

Harrison House Bathroom

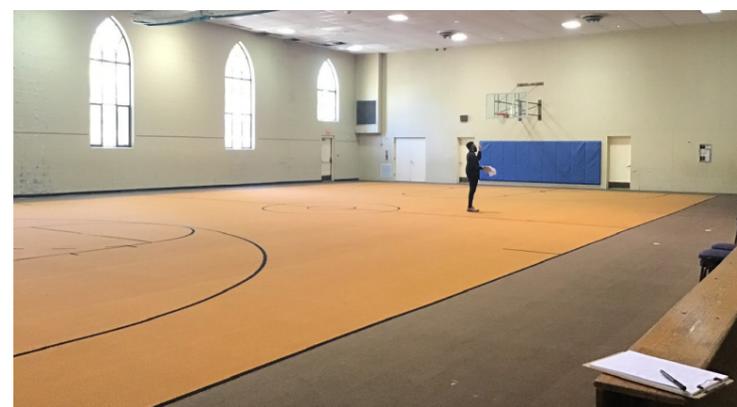
The entry lobby and mens and womens restrooms on each side of the lobby are in good shape. Both restrooms have an ADA stall. Other than the fact that they are dated, the floor and wall tile, toilet fixtures and the stalls are good condition. However, the counters and sinks are in need of replacement. The classroom above this entry would need some clean up and maintenance before it could be used. While it does have new carpet, the mill work and marker boards need replacement. Stray data and electrical wiring needs to be managed, and significant clean up is needed. The gymnasium is in need of moderate to significant renovation, including new paint, new acoustical ceiling tile, cleaning of all air registers and new flooring. At one location on the north wall of the gym, significant water damage was observed. In addition, Carpeted gym flooring is no longer used. If this space is to continue use as a gymnasium, there

are more modern materials such as a poured rubber flooring system or a wood floor. In this portion of the building it appears there the appropriate number of exits with door panic hardware. The building is equipped with a fire alarm system, but is not sprinklered.

Chancellor's Hall Gymnasium

(1) 3/5 ton AC for hall and restrooms
 -all of these are up to code with smoke detectors; no issues reported
 -In the gym there is significant dirt around all of the HVAC registers. This is indicative of leaks in ductwork allowing dust into the system. This can contribute to poor energy efficiency in the system.
 Electrical:
 All lighting throughout the building is either, incandescent, fluorescent or (in the gym) metal halide. It is recommended that all fixtures be updated to LED and that occupancy sensors be installed for energy conservation.
 Plumbing:
 All gas to the kitchen is in good condition. The restrooms/ showers off the kitchen are "limping by", and drinking fountain is not working in this area. In all other restrooms, other than the fact that the fixtures are outdated and need replacement, there are no issues to report. There is no galvanized piping in this building.

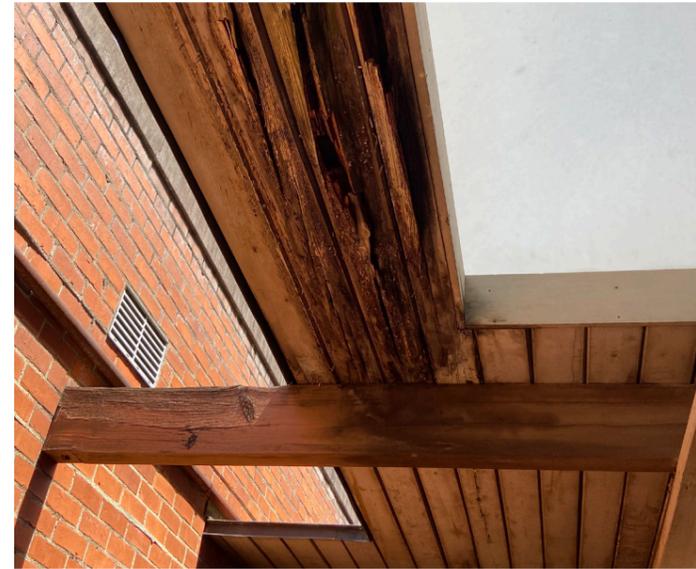
Breezeway Roof Detail

Just outside the second floor is a covered breezeway that leads to the garth and Morrison Hall. The cover over this area consists of wood rafters supporting a copper covered flat roof system with wood decking on the underside. There are four skylights in this roof. The wood decking on the underside is showing significant water damage as are the tops of the rafters. However, observation of the copper on the top of the roof appears to be in stable condition. There are likely two causes for the water damage; one- the lack of proper drip flashing on the edges of the roof, and two- seals around the skylights are failing, causing leaks onto the wood decking.

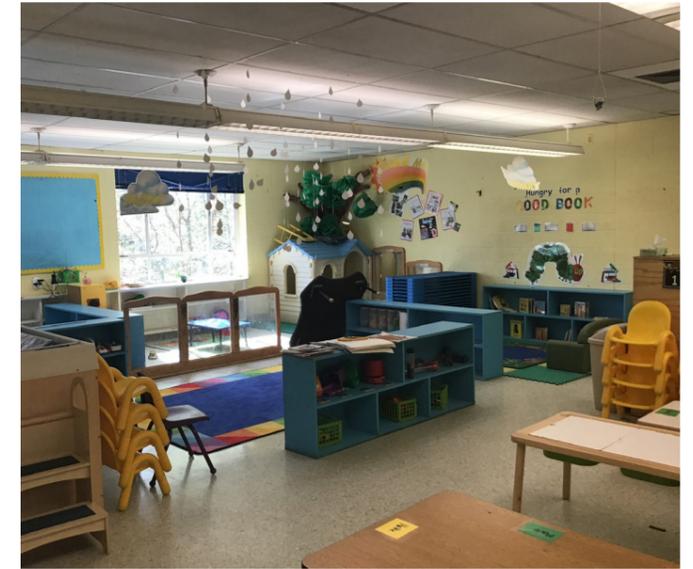
Classroom Interior

flooring, ceilings and doors are all generally well maintained. The classrooms are large, bright and spacious. The stair in this building is safe for young children. In both the 1st floor and 2nd floor jack-and-jill restrooms the fixtures and finishes are dated, but well maintained. It is recommended that in all classrooms the base cabinets and counters be replaced.

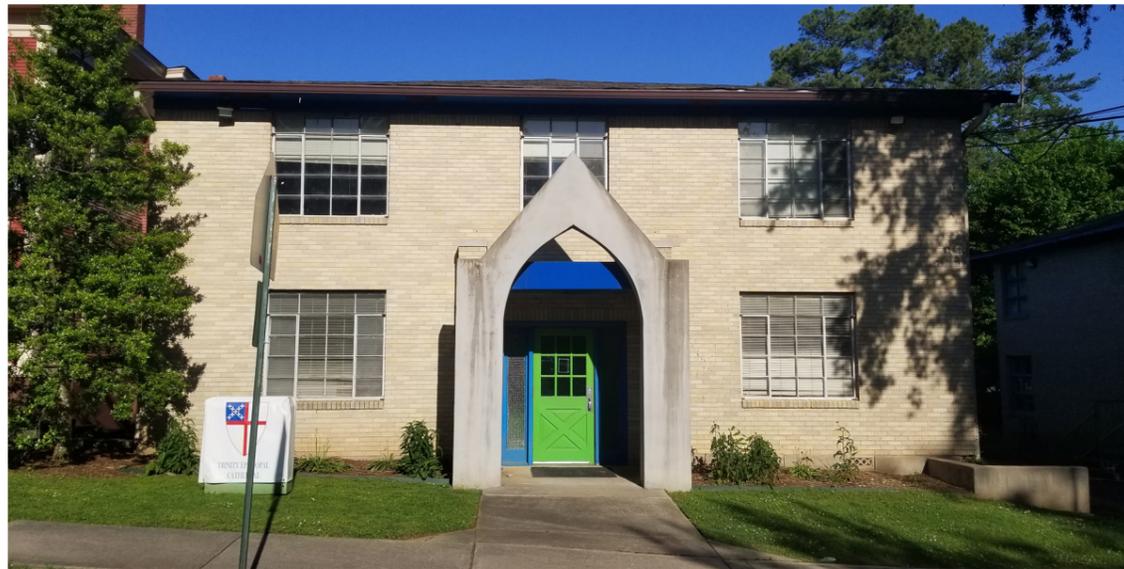
Higgins Hall

On the exterior of Higgins Hall the architect observed cracking in brick joints and spawling in the concrete foundation that may be attributed to settling. This was observed predominately on the north side of the building. A structural engineer should be consulted to verify the extent and cause of these issues. The exterior of Hodges Hall appeared to be in good condition for its age and no settling issue were observed on this building.

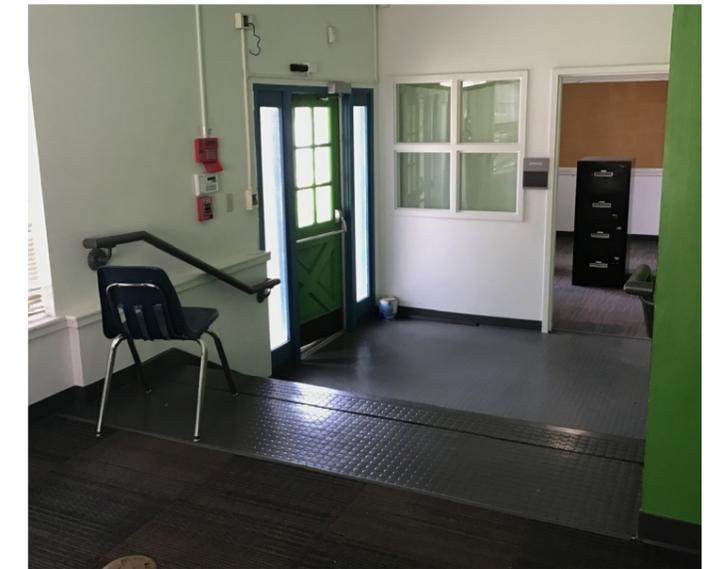
Interior Higgins Hall

Throughout the interiors of both buildings there is a significant amount of deferred maintenance to be addressed, including painting, wall repairs, door hardware repairs and general cleaning. The heaviest amount of this was generally observed in the classrooms, which is expected. Throughout the buildings, and especially in the classrooms, the 1x4 fluorescent lighting is outdated, inefficient and inhospitable. It is recommended that all lighting be replaced with new LED fixtures. All of the classrooms have extensive millwork with plastic laminate finish. Generally the millwork was observed to be in good working order and in good shape. However, the finish is considered outdated, and there are options available for resurfacing if desired. The countertops of all the millwork are outdated and in many cases damaged, and therefore should be replaced.

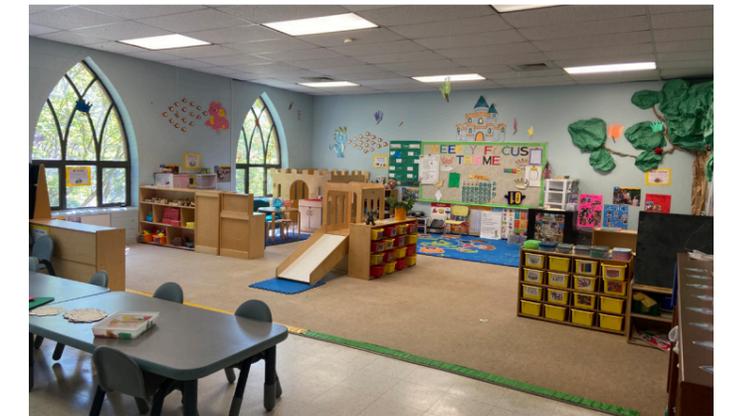
The classroom wing of Parish House is actually three levels with a single large classroom on the ground floor, the majority of classrooms and restrooms on the mid- level and more classrooms, restrooms and storage on the third level. Generally, all the classroom spaces are in good condition and well maintained. As is the case with most of the campus, millwork countertops and sinks are in need of replacement. Acoustical ceiling tiles should be replaced where stained and lighting should be upgraded to LED, with dimming recommended in classrooms. Most of the restrooms in Parish House need significant upgrade. Not only are fixtures old and outdated, the layouts are not ADA compliant.

Classroom Interior

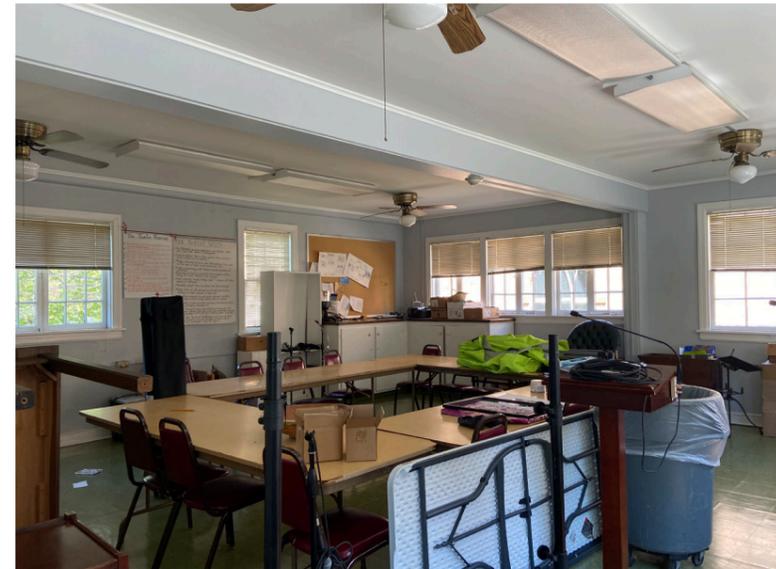
On the first floor there is some evidence of water damage to plaster as referenced in the earlier paragraph. The floor tile on the appears to be the same asbestos tile seen in Morrison Hall. There is one bathroom in the building which has been renovated. The upstairs has new carpet and appears to be well maintained.

First Floor, Mitchell House
