Trinity
Episcopal
Cathedral

FEASIBILITY ASSESSMENT +
MASTER PLAN FALL 2021

| POLK | STANLEY | WILCOX

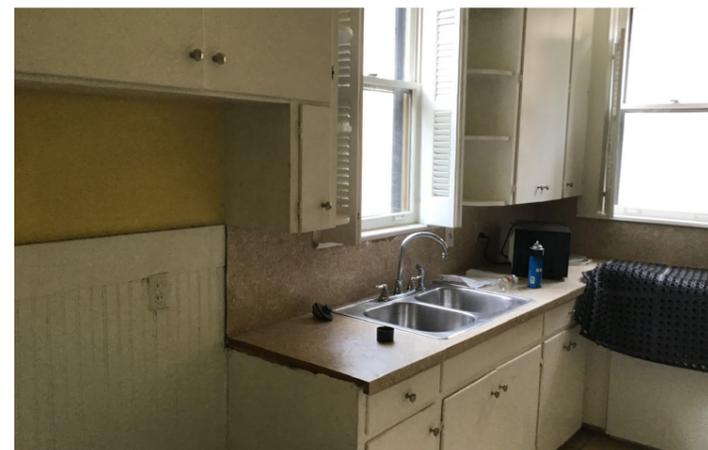
Harrison House Kitchen

The kitchen and all bathrooms in their current state are unusable and in need of complete renovation. In the kitchen there is one wall cupboard that may be original to the house which could be saved for its historic value. Otherwise all other cabinetry, counter tops and appliances should be replaced. It is the architect’s opinion that only one of the three bathrooms is original to the house due to its period fixtures and wainscoting. The other two restrooms appear to be poorly executed remodels. None of the three bathrooms are ADA compliant.

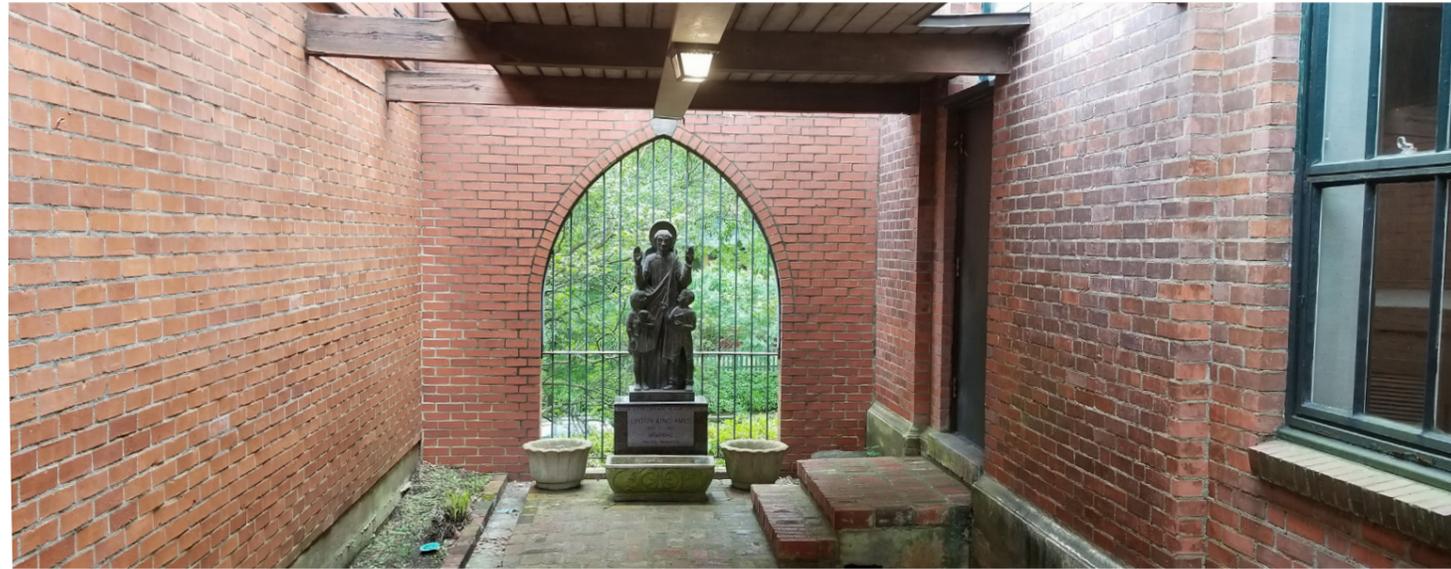
Breezeway

Just outside the second floor is a covered breezeway that leads to the garth and Morrison Hall. The cover over this area consists of wood rafters supporting a copper covered flat roof system with wood decking on the underside. There are four skylights in this roof. The wood decking on the underside is showing significant water damage as are the tops of the rafters. However, observation of the copper on the top of the roof appears to be in stable condition. There are likely two causes for the water damage; one- the lack of proper drip flashing on the edges of the roof, and two- seals around the skylights are failing, causing leaks onto the wood decking.

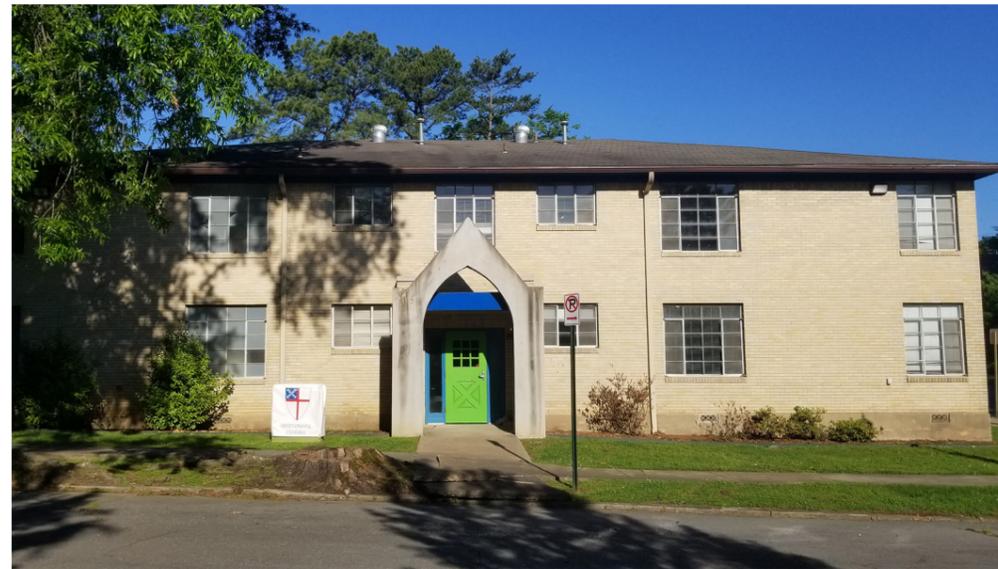
Hodges Hall has three new unit, but also has three air handlers that are beyond their useful life and should be replaced.

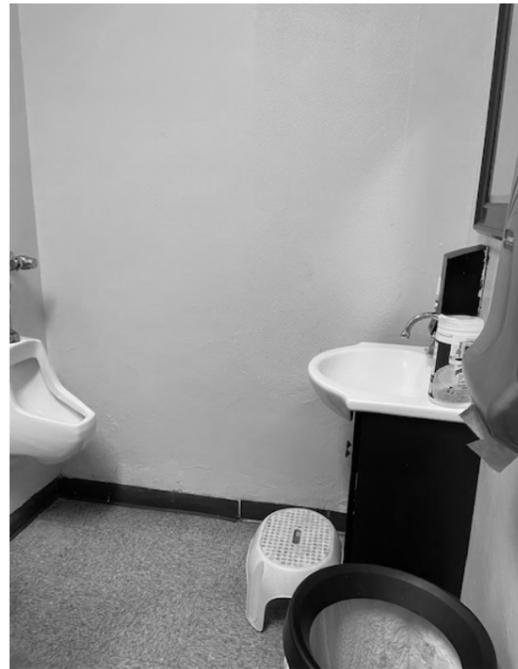
Existing Parish Single Restroom

The classroom wing of Parish House is actually three levels with a single large classroom on the ground floor, the majority of classrooms and restrooms on the mid- level and more classrooms, restrooms and storage on the third level. Generally, all the classroom spaces are in good condition and well maintained. As is the case with most of the campus, millwork countertops and sinks are in need of replacement. Acoustical ceiling tiles should be replaced where stained and lighting should be upgraded to LED, with dimming recommended in classrooms. Most of the restrooms in Parish House need significant upgrade. Not only are fixtures old and outdated, the layouts are not ADA compliant.

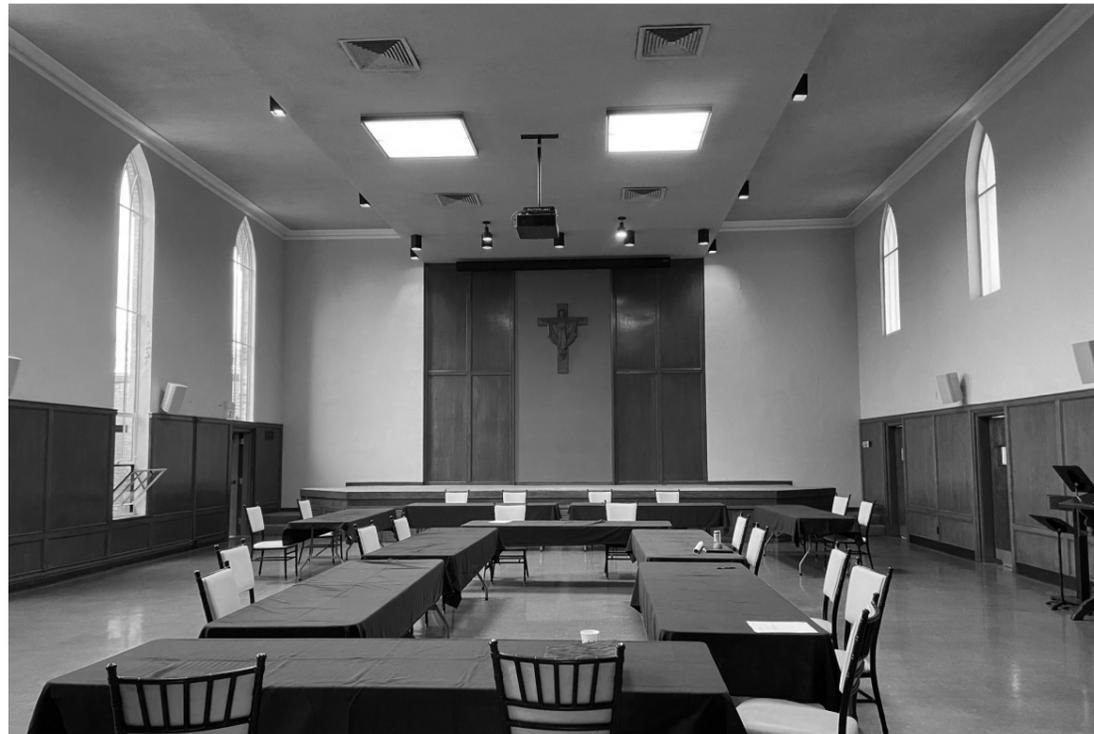
Existing Morrison Hall

Morrison Hall has received several renovations through the years. Currently the space is in good condition, except for water damaged plaster on the north wall as mentioned in the previous paragraph. It should be noted that the flooring in Morrison Hall and the pre-function area that serves it both have asbestos floor tile. Additionally, the spray ceiling material in Morrison Hall is

Morrison Hall is typically used for parish gatherings such as seated banquets, speaking presentations, or ECEP children's performances. However, the room is not acoustically tuned to accommodate these functions. While there are absorptive panels at the rear of the room, the majority of surfaces are sound reflective. This creates an acoustically "live" space making speech audibility difficult. An acoustical consultant can be engaged to make recommendations for better acoustical control.

The room is equipped with AV for presentations, but there is no ability to control lighting (both natural or artificial). New LED lighting with dimmer controls is recommended.
